BARNs

Like the houses in the rural areas of the region, the typical stable-loft barns have undergone a considerable, and interesting, evolution over the past one hundred years. The growing size of the farm, technical advances, and changes in available manpower all affected the development of the barn in Elton-Cornwallis. The transformation of the barn in this area has not been completely regular, however. Economic conditions, especially, disrupted or prolonged certain stages in the progression from the earliest crude barns of the 1870s to the large frame barns of the 1920s. Despite these inconsistencies, some basic barn types have been identified. Four main stages in this process are discernible: during the nineteenth century: 1) Initial structures, 2) Early frame barns, and, 3) Southern Ontario-style barns; and during the twentieth century, 4) plank framed barns. The increasingly sophisticated planning, construction and decoration that characterized barn development in the planning district can be better understood with an analysis of these four barn types.

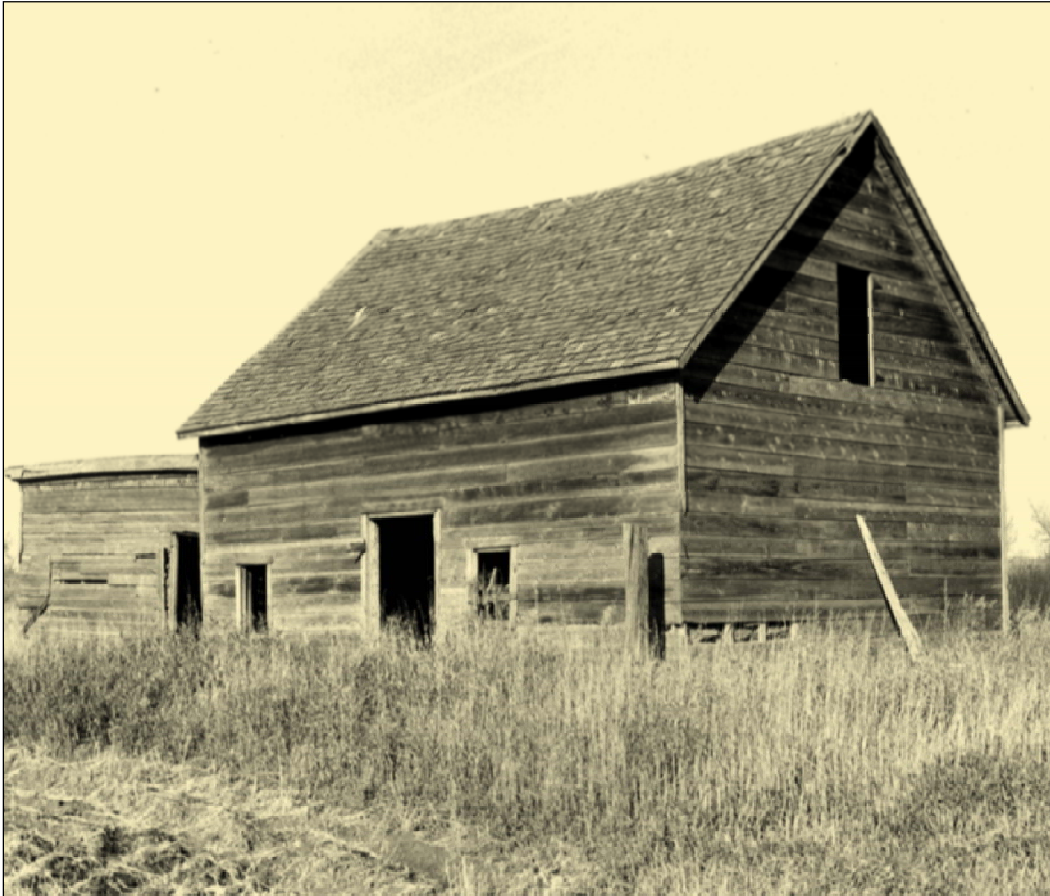
Figure 30
Early log barn, NW 3-11-17W, ca. 1880.
The framed lean-to on the left was a later
addition.

Only three log barns were located in the survey; one is just to the west of Douglas, while the other two are in the Brandon Hills. The barn near Douglas, which appears to be the oldest of the three, offers a fair representation of early log construction (Figure 30). The exterior walls which were built of 180 to 200 mm (7" to 8") wide logs, either peeled or roughly squared on two sides, were sheathed over with horizontal drop siding (Figure 31). The interior corners suggest that the walls were connected by dovetail joining, the same technique used in pioneer residential construction. The loft gable end walls were constructed with 40 x 80 mm (2" x 4") studs. Because the only function of the loft floor was to store feed, the careful notching used to secure the log walls was unnecessary. The loft floor was made of 50 to 70 mm (2" x 3") wide rails that were simply laid across the larger 100 to 125 mm (4" to 5") wide beams. The roof was, like the loft floor, hastily constructed (Figure 32).

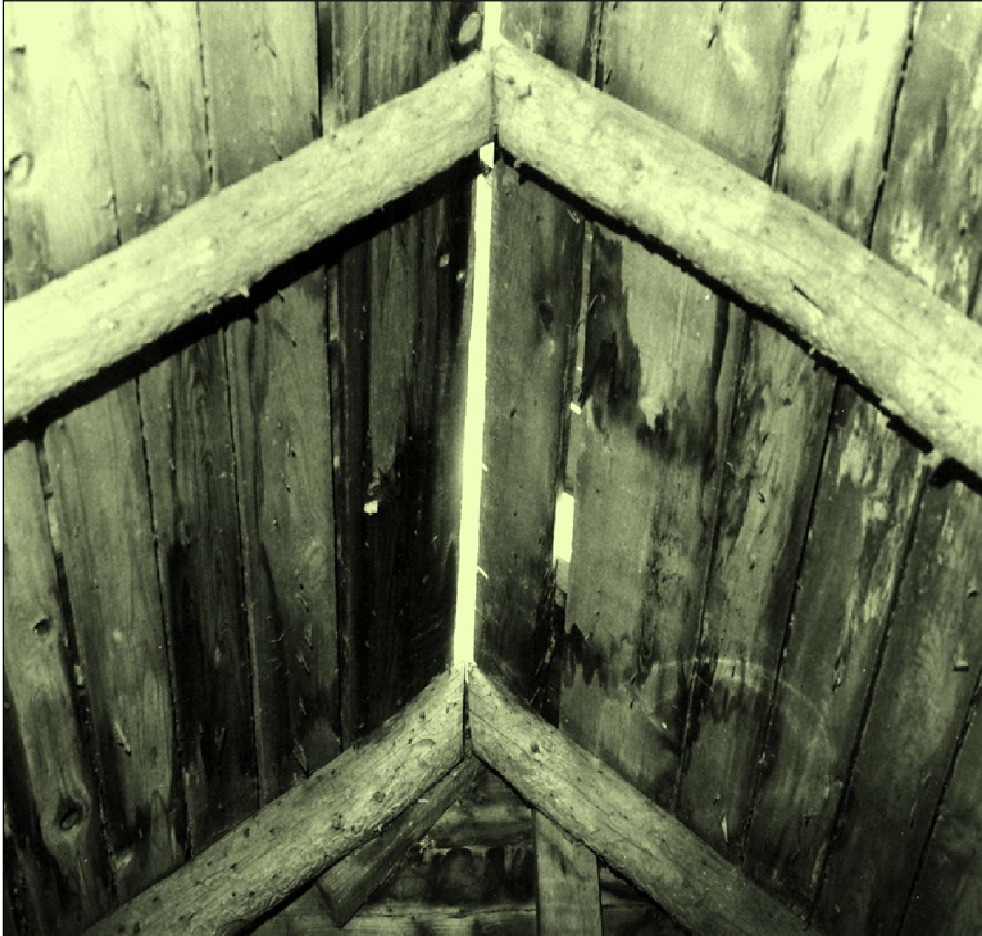
Figure 32

Early log barn, NW 3-11-17W. The roof construction of this log barn consisted of rough log rafters that sat in a notch in the wall sill plate and were connected at the roof peak by butt joints. Without notching, the rafter ends were cut at rough angles so they could be toe-nailed together. The rafters were covered by planking and shingles.

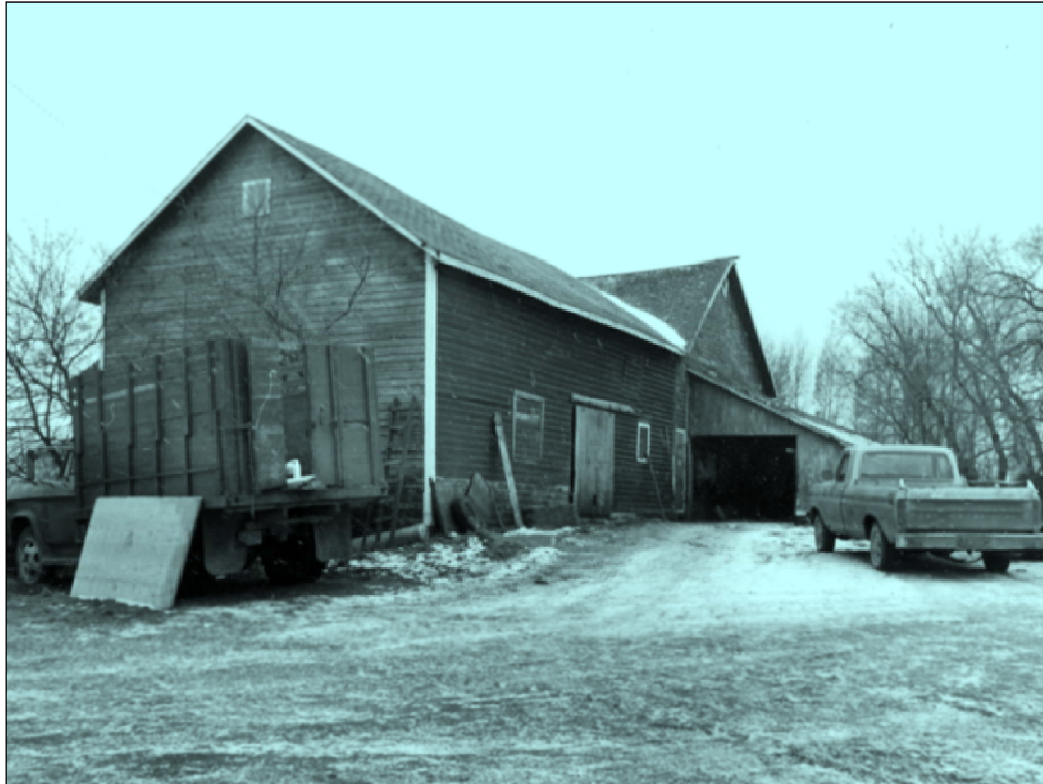
Figure 33

Hutton Barn, SE 4-10-19W, ca. 1885. The original bank barn, from the northeast, shows the hillock that provides upper level access to the loft. This section has square nails, a feature helpful for dating nineteenth century construction.

The original portion of a barn at SE 4-11-19W, in Cornwallis, is an interesting example of an early framed bank barn (Figure 33). Built by Robert Hutton in the 1880s when this kind of barn was most common, its planning and construction illustrated general bank barn characteristics (Figure 34).

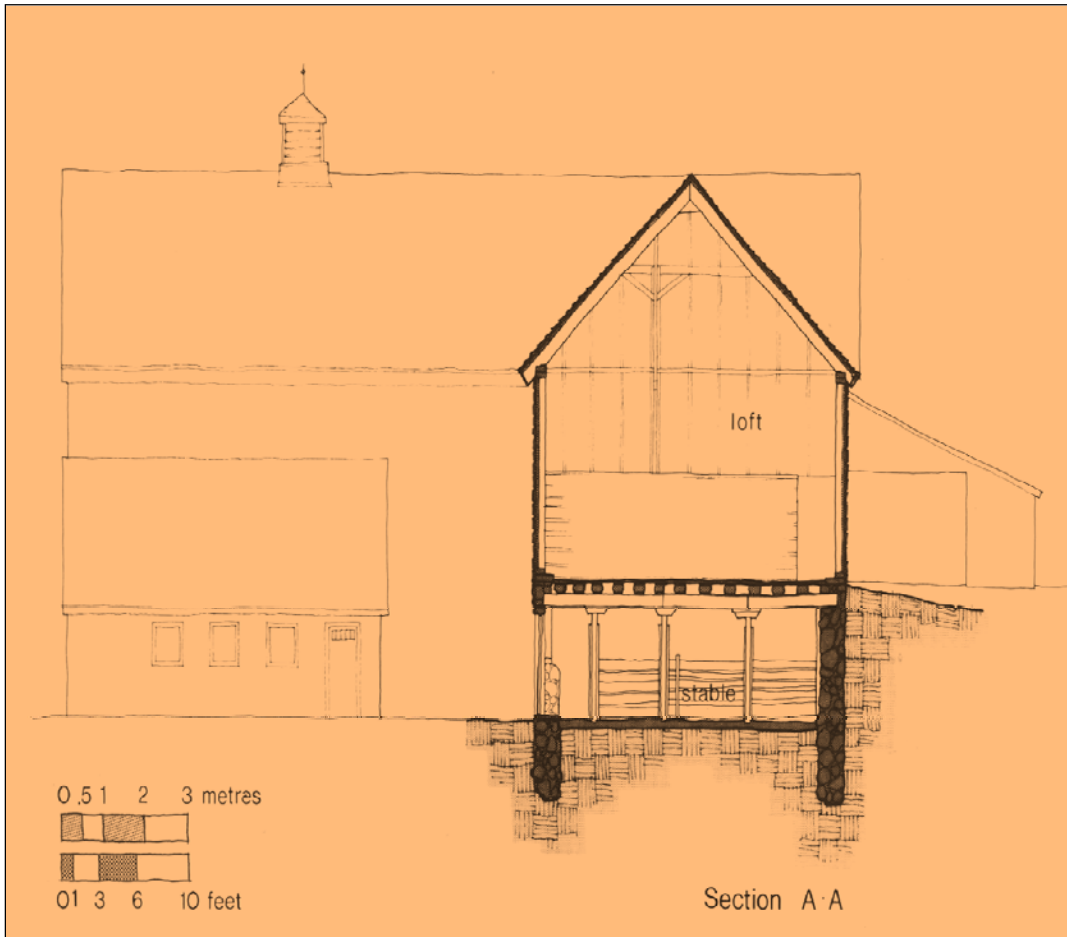
Figure 34

Hutton Barn: cross section of the original barn and elevation of the barn addition. The north ramp to the loft and lower access to the stable that were characteristic of early bank barns are evident here. The typical framing procedures in the loft consisted of stud walls sheathed with horizontal siding and rafters covered with planks and shingles. The rafters were stabilized with a horizontal connecting strut nailed about 0.6 m (2') below the roof peak.

The small fieldstone stable was simply planned. It was divided into two sections: one for horses, one for cattle. Two separate doors on the south permitted access for six horses into one side and ten or twelve cattle into the other. The loft was also straightforward. While it has been partitioned into small rooms, it was originally an open space with a drive-in central alley, flanked by two storage areas.

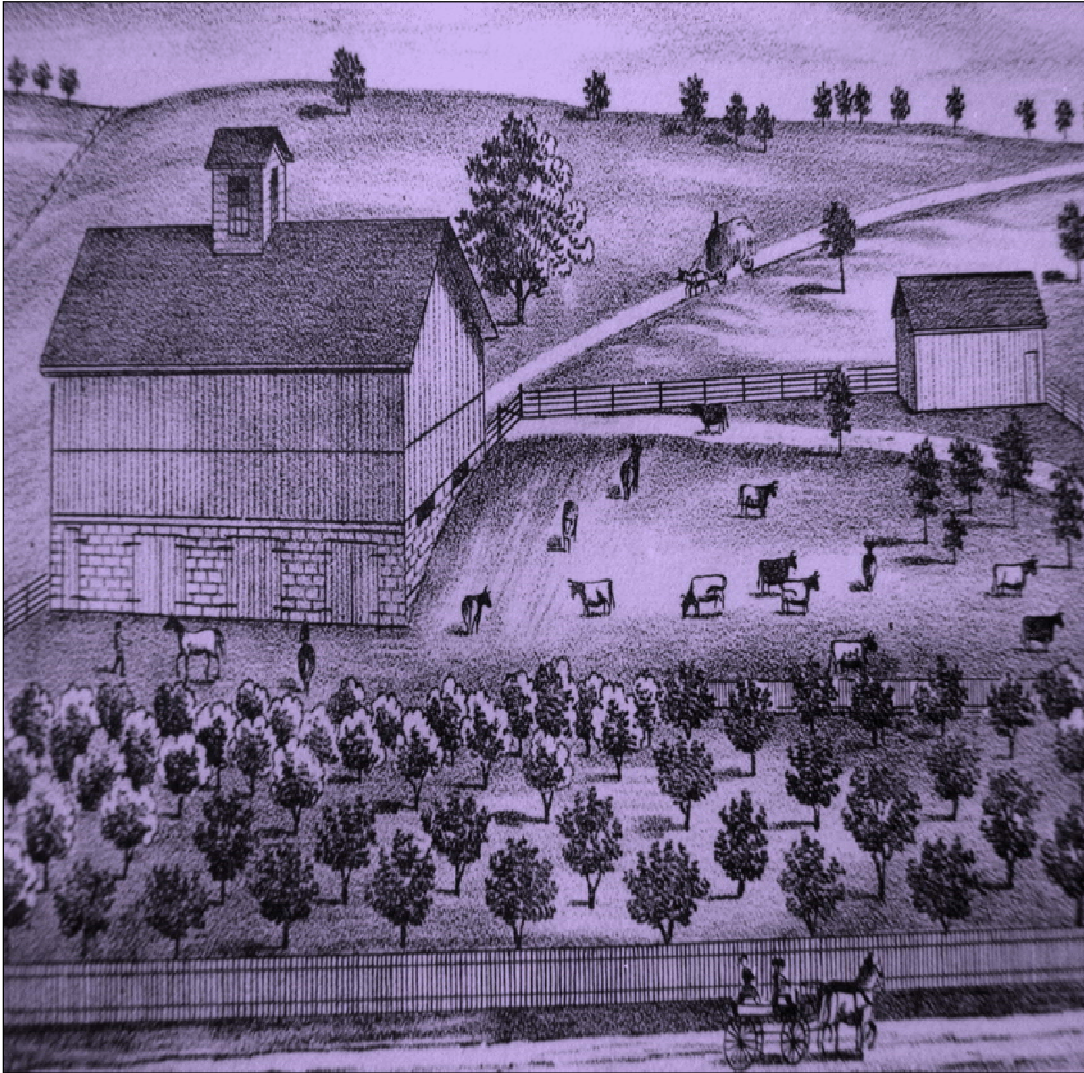
Figure 35

A southern Ontario style barn, built during the 1860s in the county of Hastings. (Illustrated Historical Atlas of the Counties of Hastings and Prince Edward.)

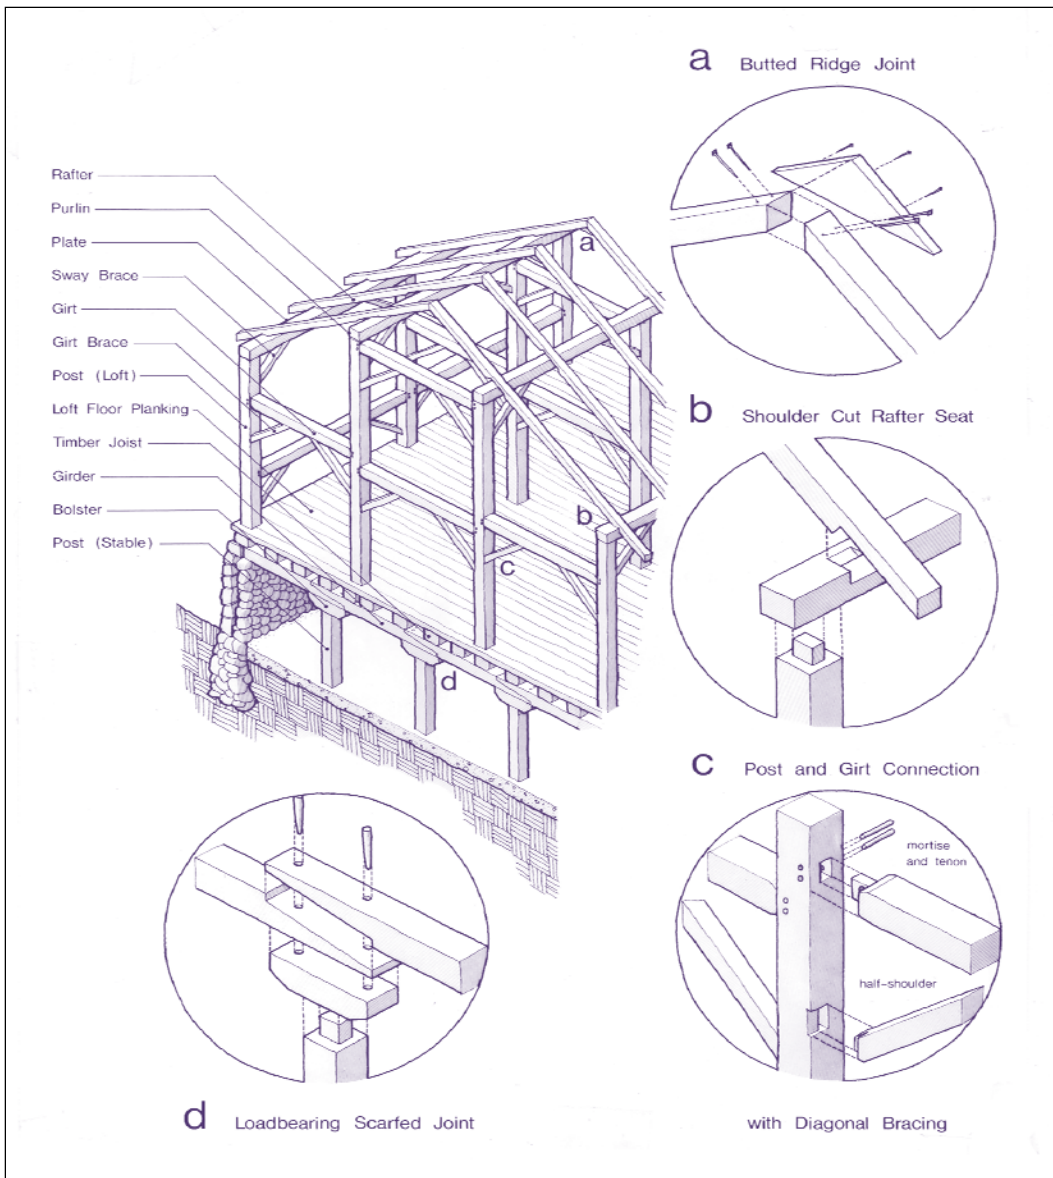
Figure 36
 The construction procedures used for a typical southern Ontario style barn featured some interesting details.

This system of posts and beams in the loft was generally referred to as bentwork. Each set of posts and beams running across the width of the building was called a bent. Barn sizes were frequently expressed in terms of the number of bents; large barns could have seven or eight bents, small barns typically had four bents. The Ferguson barn at SE 30-11-18W, with four bents is a very good example of the smaller southern Ontario style barn (Figures 37 and 38). The planning of this barn, like the earlier framed bank barns, was based on an east-west orientation that permitted dual stable access from the south. The loft, entered from the north hillock, had a central drive-in alley with flanking storage bins (Figure 39). The elements of the bentwork in the Ferguson barn consisted of 250 x 250 (10" x 10") posts, 180 x 180 (7" x 7") connecting girts and 40 x 80 (2" x 4") diagonal braces (Figure 40). All of these connections were secured with straightforward mortise-and-tenon joints (Figure 36(c) and 41).

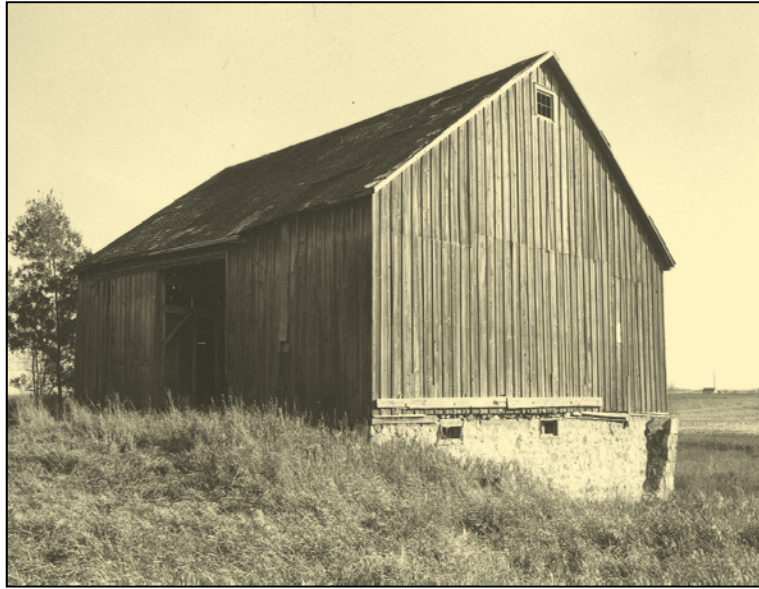
Figure 37

Ferguson Barn, SE 30-11-18W, ca. 1890. This northwest view shows the hill that permits access to the loft. The location of the internal structural members can be discerned by the jogged horizontal joints in the siding.

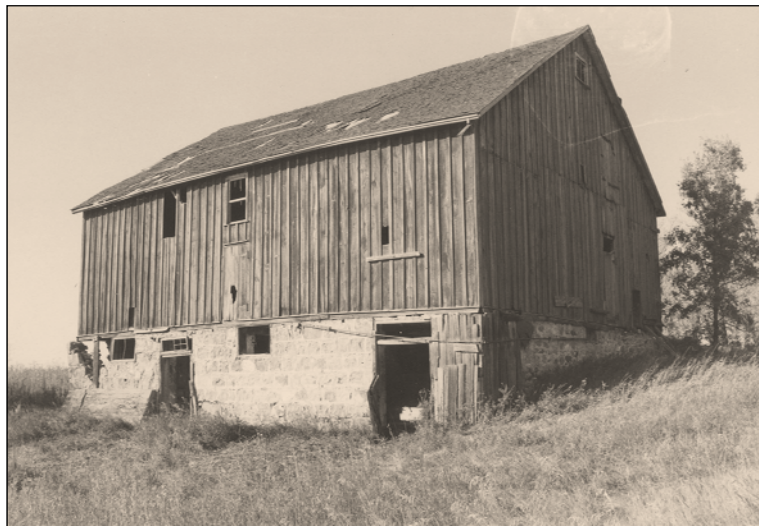
Figure 38

Ferguson Barn. The southwest view features the stable entrances at the ground level, the fieldstone foundation walls and the vertical board-and-batten siding.

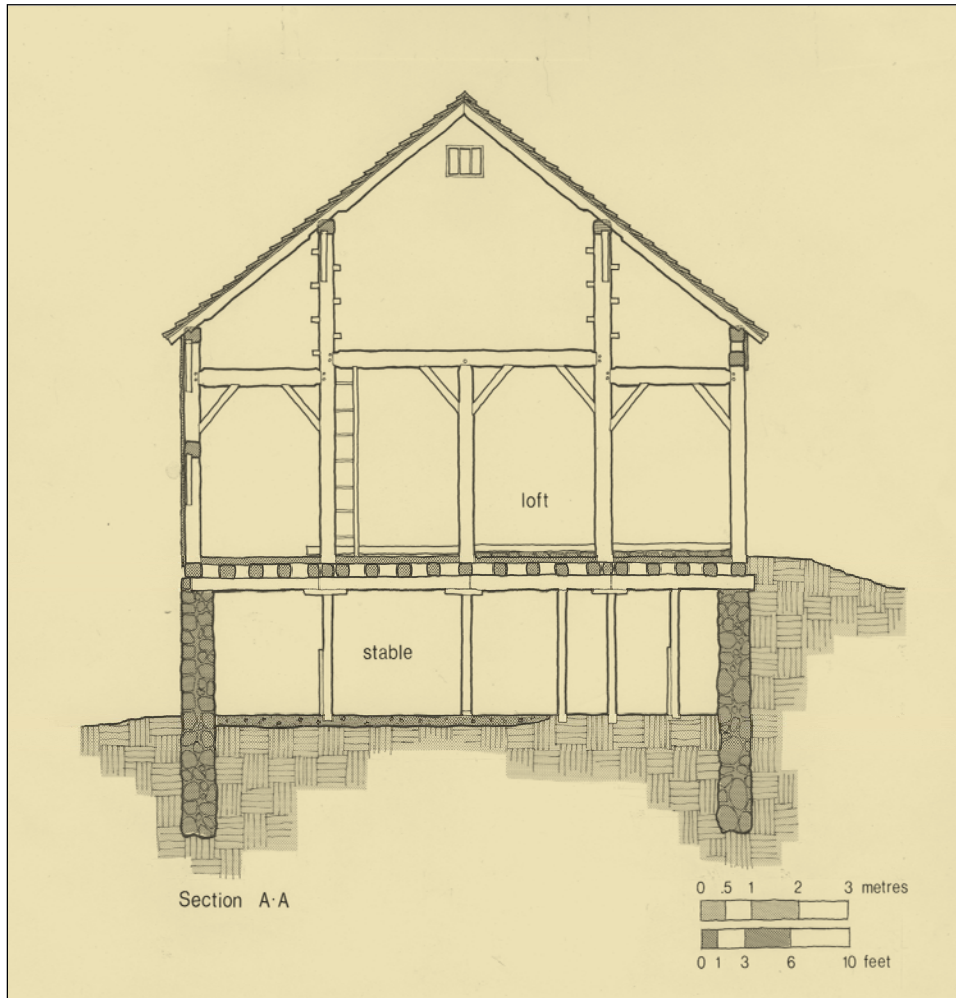
Figure 40
Ferguson Barn: section. This cross section shows the access at two levels, the loft bentwork and the fieldstone walls. The pegs on the two interior posts provided access to the upper areas of the loft.

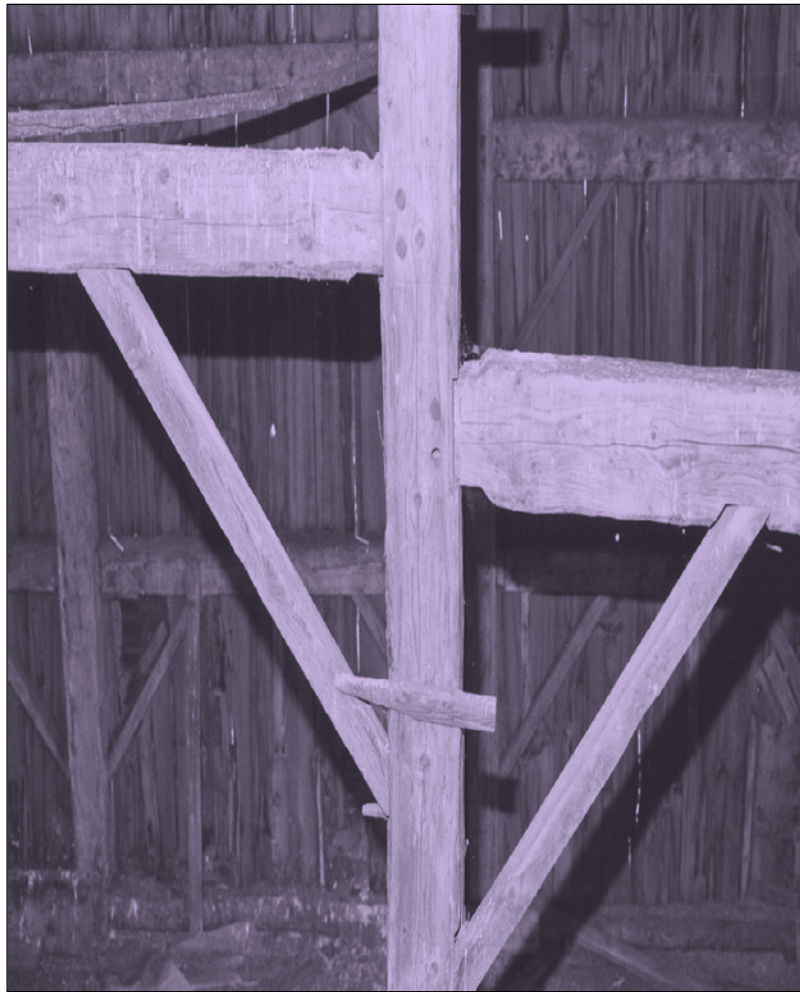
Figure 41

Ferguson Barn. Typical post, beam and diagonal brace connection in the loft. The staggered beams were connected to the post with mortise-and-tenon joints. The notched beams created a more secure structural connection as well as an interesting decorative feature.

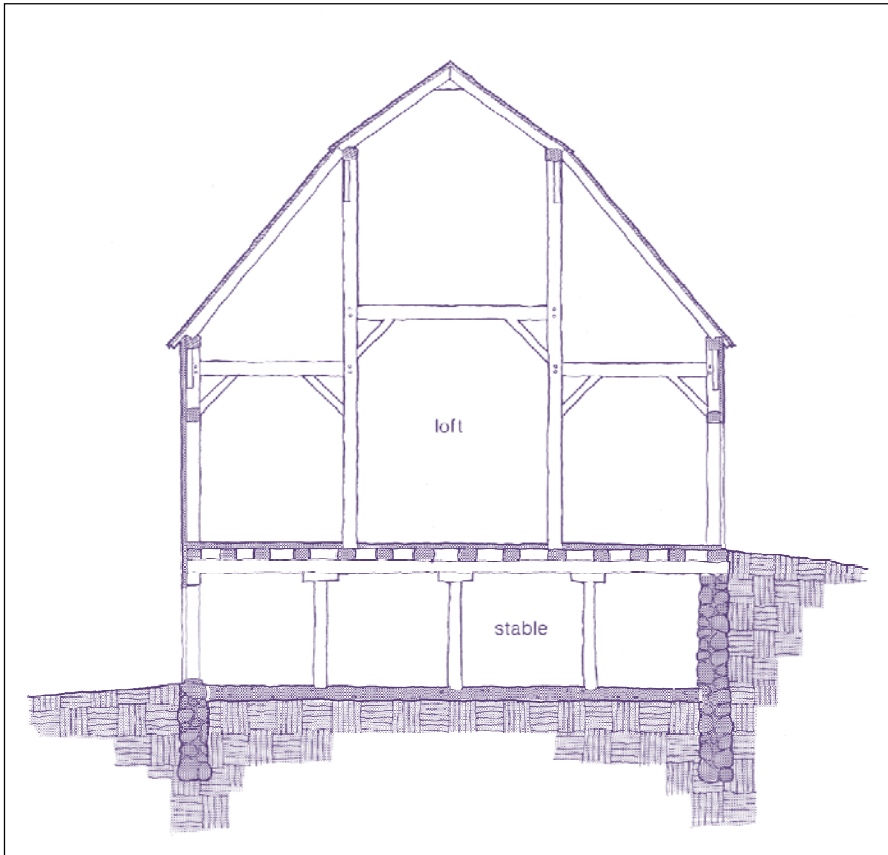
Figure 42

Typical gambrel-roofed southern Ontario style barn. The central bay was narrower and the two centre posts were taller than barns with a gable roof. The rest of the barn was constructed and planned like earlier southern Ontario style barns.

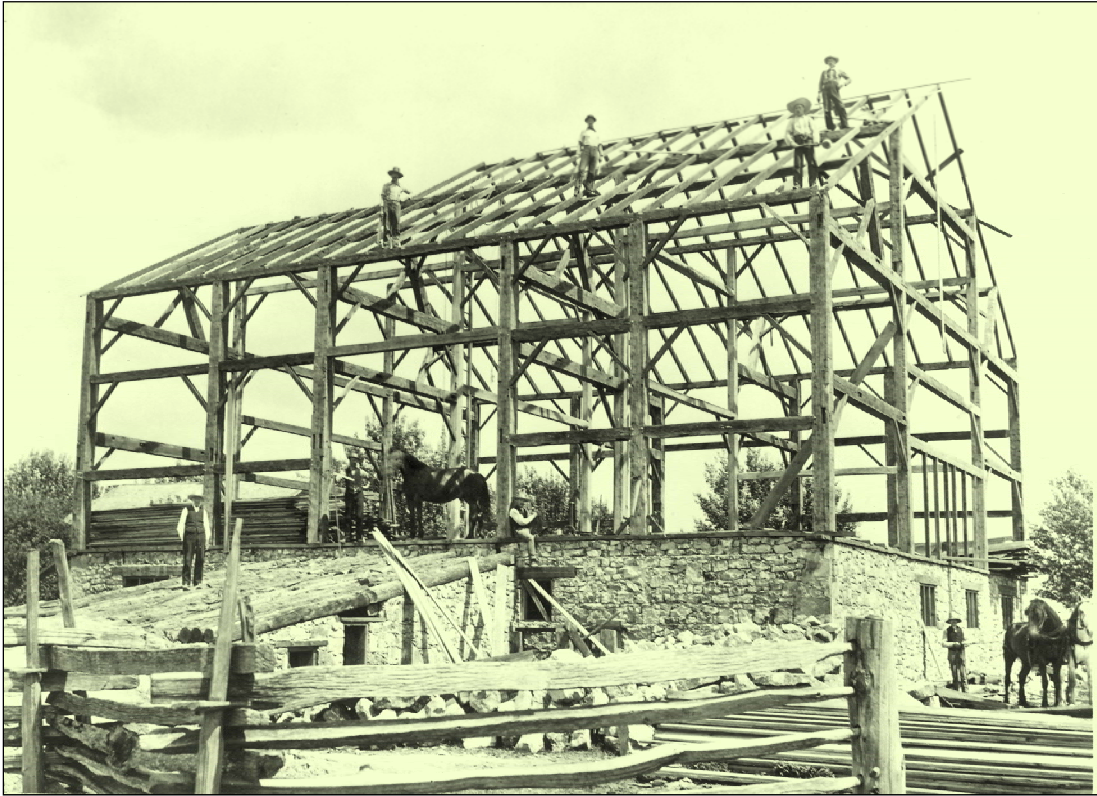
Figure 43

A barn-raising near Douglas nears completion of the structural skeleton on this six bent barn. The long built-up ramp was covered with large logs. The planking used for the siding and the roof can be seen inside the barn, on the left. The siding and roofing were usually finished by the farmer, his sons and hired help. (F. Willmott)

While southern Ontario style barns relied on the same orientation, internal layout and construction procedures that characterized their smaller predecessors, certain developments changed the nature of the new barn. A gambrel roof, which provided a larger loft capacity, replaced the moderately-pitched gable roof of earlier southern Ontario style barns (Figure 42). Instead of relying on a hill for access into the loft the new barns were generally accessed by a built-up earth ramp on the north side. Because these barns required a larger work force for their construction, barn-raising bees were often organized. Local neighbours volunteered their time and gathered at the site, where, under the direction of a carpenter, they constructed the stable walls and structural frame (Figure 43).

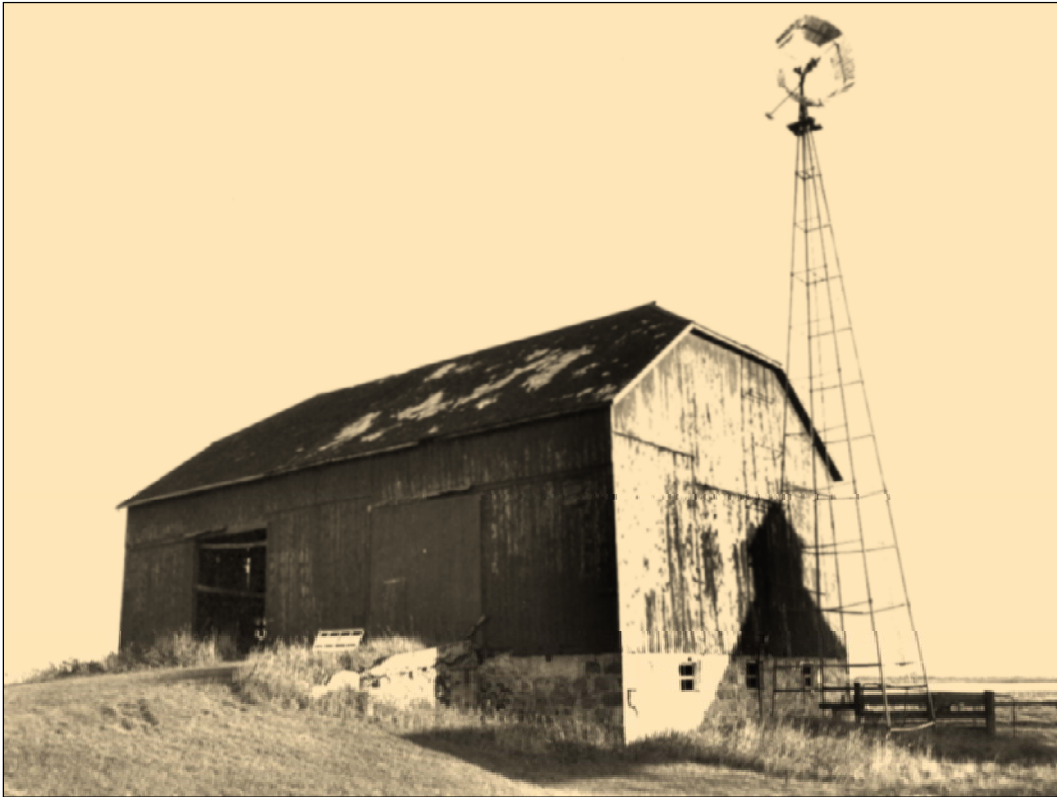
Figure 44

McCallum Barn, SW 3-11-18W, 1900. This northwest view shows the built-up north ramp and the characteristic gable end jog in the vertical sheathing. This jog, the reverse of the Ferguson barn jog, was required by the slightly different bent arrangement.

A number of these large southern Ontario style barns were built around Brandon before 1920. The McCallum barn, built just at the turn of the century, is a very interesting example of the mature southern Ontario style barn (Figures 44 and 45). The bentwork in the loft and the construction of the stable reflect the basic similarities to the Ferguson barn. The planning, however, of the McCallum barn represents an advance over the Ferguson barn. The access alleys divided the large loft into three storage areas while, in the stable, the stalls were arranged into a neater grid (Figure 46). Although more animals could be housed in the McCallum barn, the individual stalls were not appreciably better than those in the Ferguson barn. The addition of the root cellar, however, made the McCallum stable more useful. The building, which has been dismantled, offers an excellent view of typical southern Ontario barn construction (Figure 47).

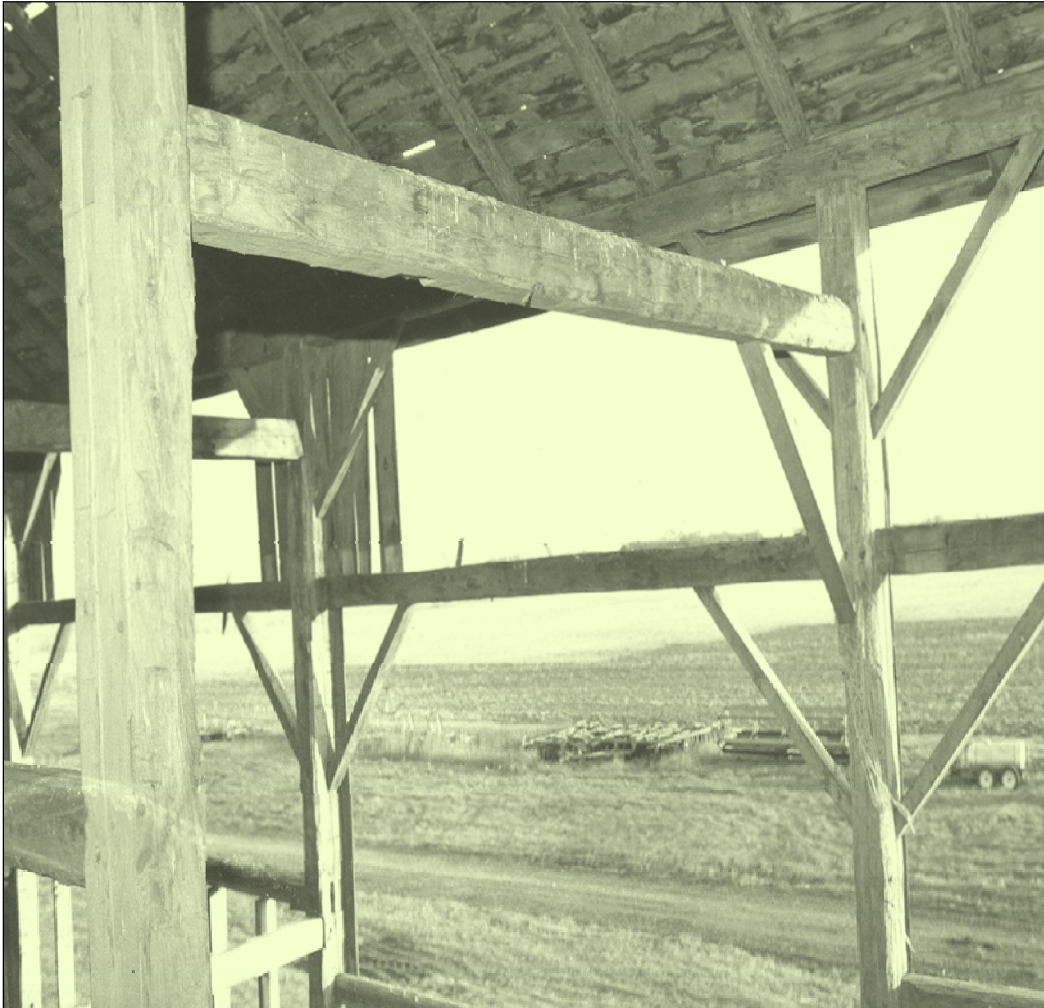
Figure 47
McCallum Barn. The vertical siding removed from the south side of the barn reveals the heavy timber framework.

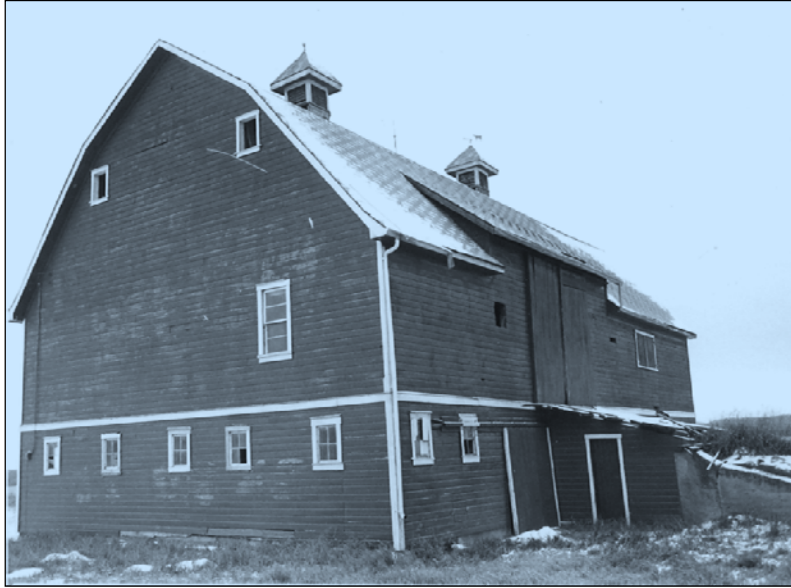
Figure 48

McPherson Barn, NE 9-9-18W, 1923. The narrow north ramp on this barn allowed light and air into the northern half the stable. The typical southern Ontario stone stable walls were replaced with a lighter sheathed frame

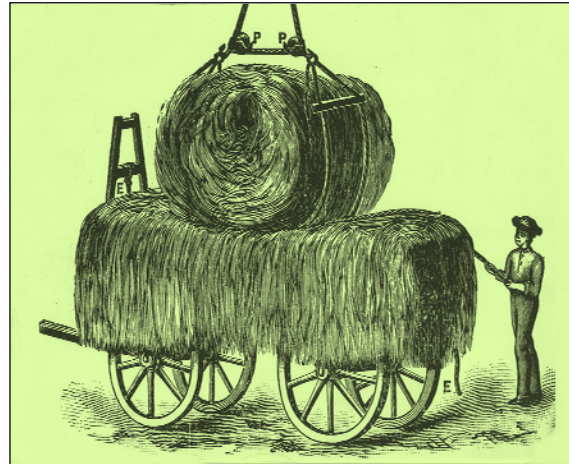
Figure 49

A hay sling, which was connected to a moveable pulley attached to a track in the roof peak, could distribute hay to various parts of the loft. (Provincial Archives Manitoba.)

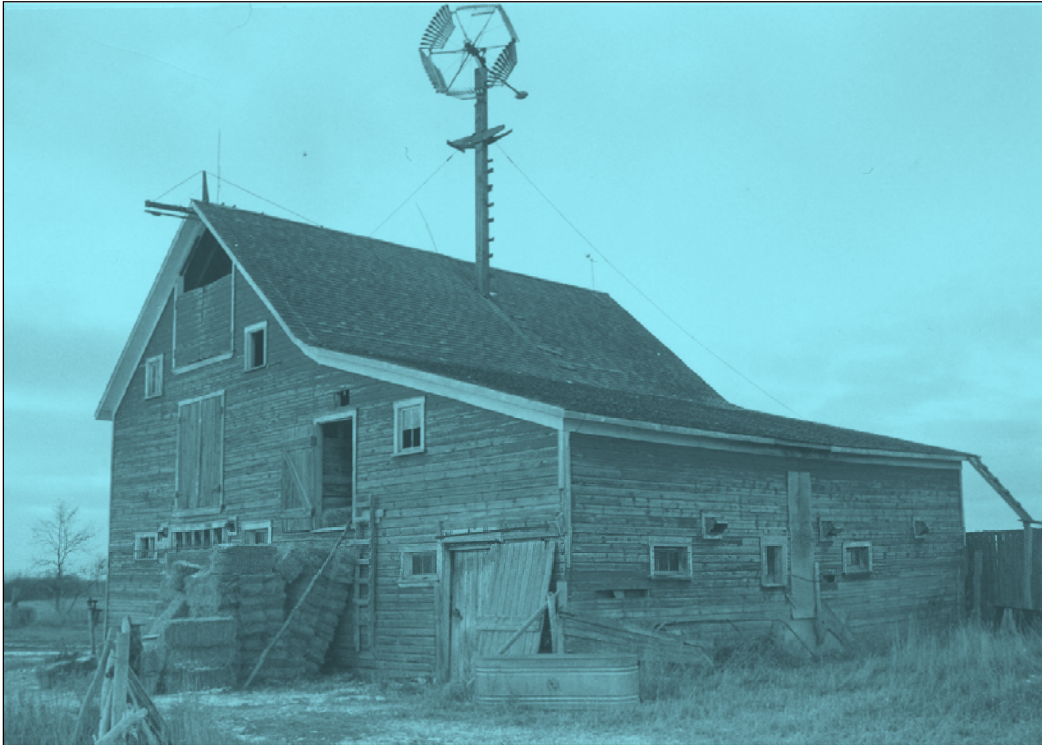
Figure 50

Kneeshaw Barn, SW 21-9-17W, 1905. This view from the southeast shows the hay sling's extended track which was added after the barn's construction. The windmill was used to provide power for moving and crushing feed inside the barn.

The modestly-sized Kneeshaw barn, built in 1905 at SW 21-9-17W shows the introduction of some of these developments (Figure 50). The southern Ontario style ramp was excluded and access into the stable was gained through two doors in the north or two doors on the south (Figure 51). The construction of this barn resolved the discrepancy between loft and stable connections (Figure 52). While construction details reveal some dependence on southern Ontario joinery the bentwork was simplified by eliminating some horizontal members. This development permitted easier movement in the loft.

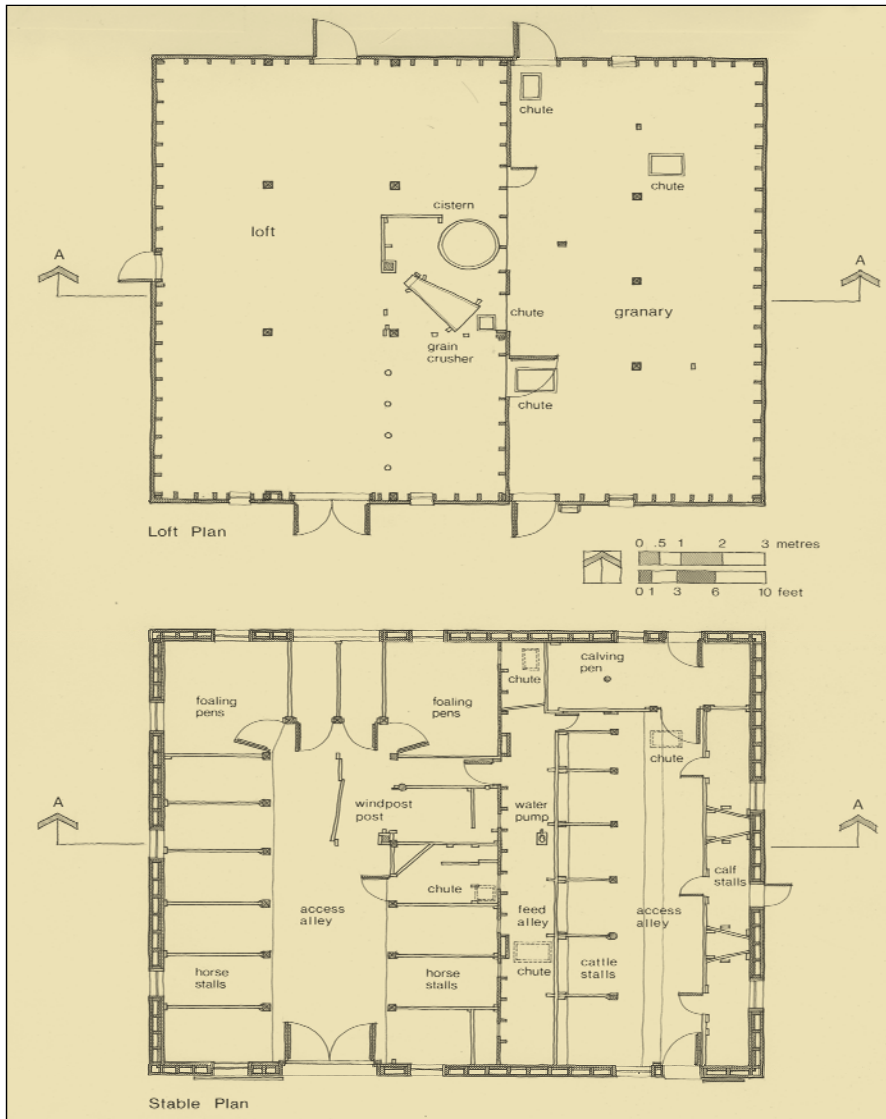
Figure 51
Kneeshaw Barn: loft and stable plans

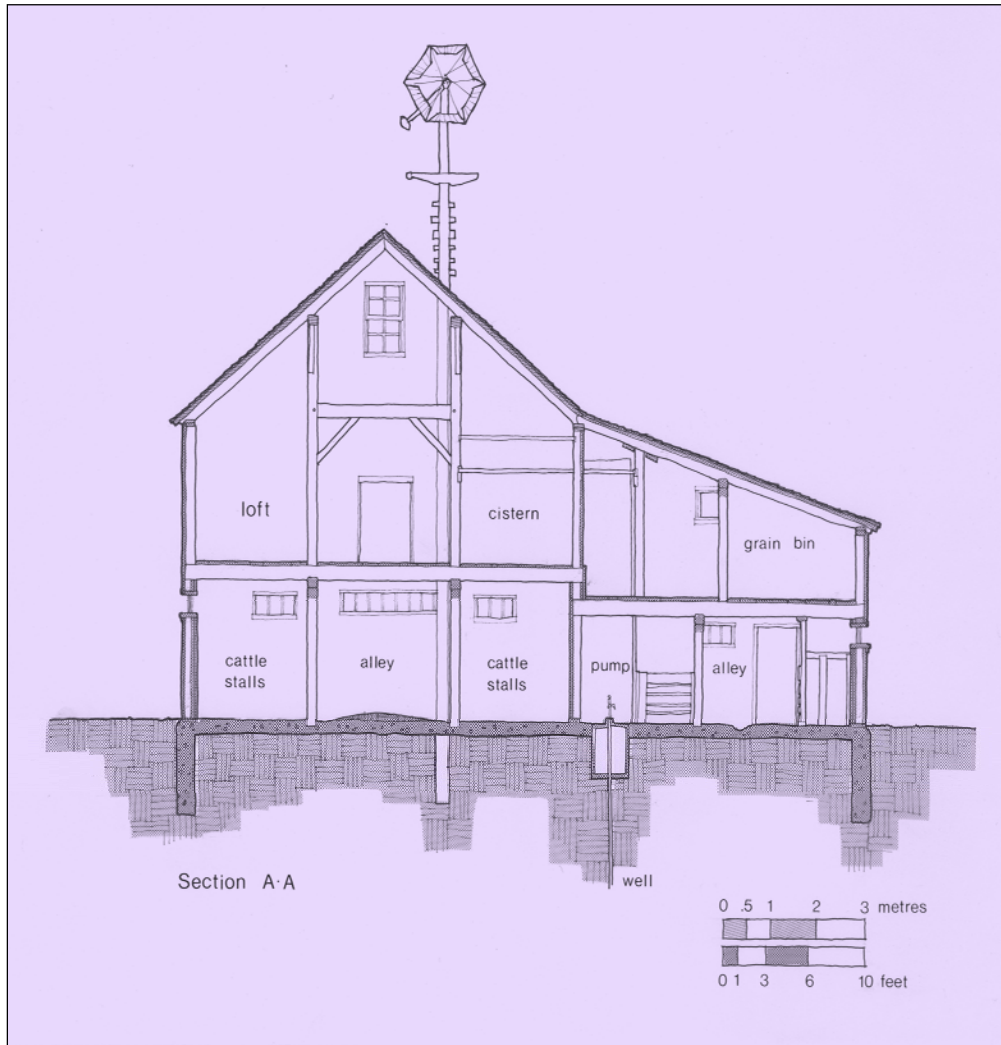
Figure 52
Kneeshaw Barn: section. The posts from the loft extended directly in a line to the stable posts.

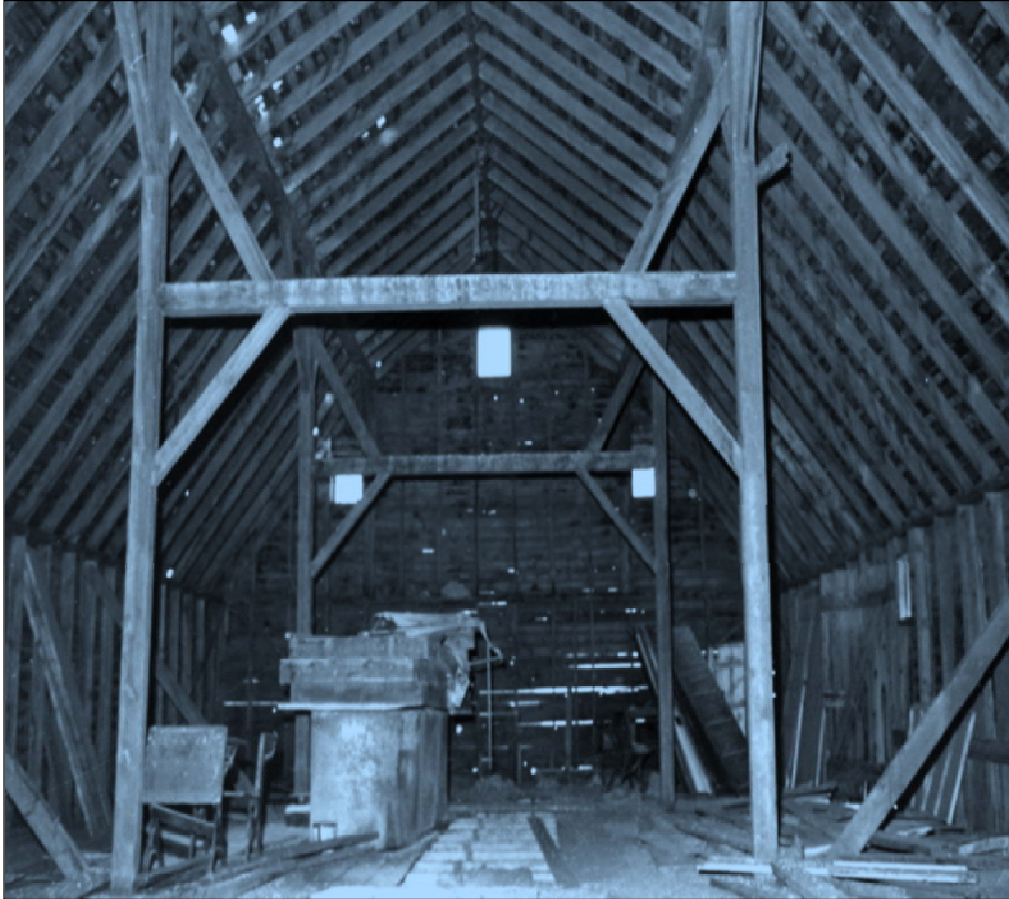
Figure 54
Roddick Barn. The builders of Nova Scotia style barns concentrated the main structural supports away from the walls, increasing internal stability and freeing the external walls for frame construction.

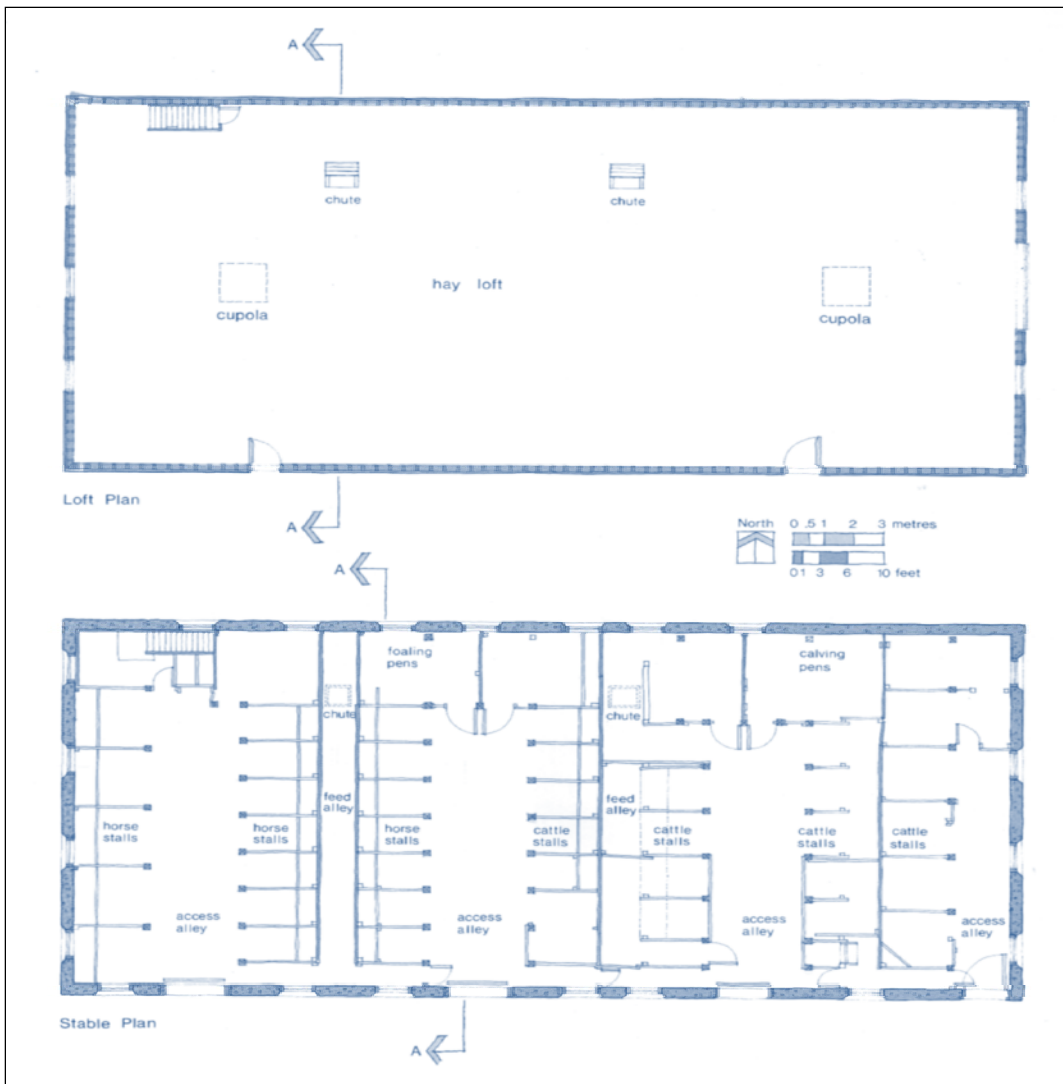
Figure 57
 Shields Barn. Without the necessity of supporting a heavy loft network, the spacious stable was well organized; the western section was for a few horses, the two eastern sections were for cattle.

Barns built with plank framing were ambitious in design and scale. The Shields barn, built from 1910 to 1912, at NW 8-9-19W, reveals the advanced state that barn building in the Brandon area had attained (Figure 56 and 57). While the barn was built with concrete stable walls and was not planned with a long central alley, the huge open loft was very modern (Figure 58). Constructed using a series of plank trusses, the voluminous space in the loft allowed a hay sling complete freedom of movement along a track in the roof peak (Figure 59). Hay and grain could be lifted from wagons on the east side and shifted easily through any part of the loft. The Shields barn was built as a physical and technical rival to the new livestock barn at the Brandon Experimental Farm. The barn at the experimental farm burned in 1916 and the Shields barn now stands as one of the few remaining large truss-roofed barns in the Brandon area.

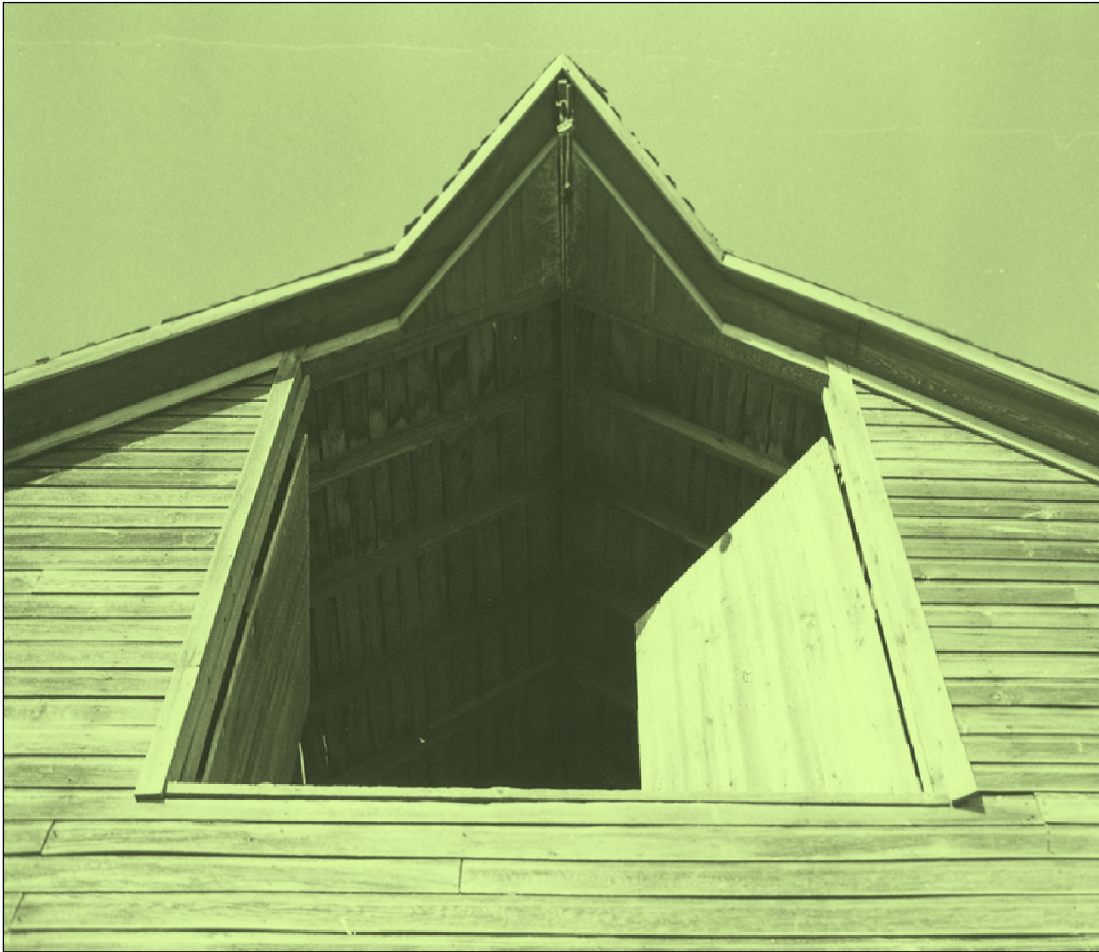
Figure 59

The extended hay sling required the addition of a roof peak that provided protection for feed lifted up to the loft. Loads could be pulled inside more easily through the large loft doors.
