BARNs

Like the houses in the rural areas of the region, the typical stable-loft barns have undergone a considerable, and interesting, evolution over the past one hundred years. The growing size of the farm, technical advances, and changes in available manpower all affected the development of the barn in Elton-Cornwallis. The transformation of the barn in this area has not been completely regular, however. Economic conditions, especially, disrupted or prolonged certain stages in the progression from the earliest crude barns of the 1870s to the large frame barns of the 1920s. Despite these inconsistencies, some basic barn types have been identified. Four main stages in this process are discernible: during the nineteenth century: 1) Initial structures, 2) Early frame barns, and, 3) Southern Ontario-style barns; and during the twentieth century, 4) plank framed barns. The increasingly sophisticated planning, construction and decoration that characterized barn development in the planning district can be better understood with an analysis of these four barn types.

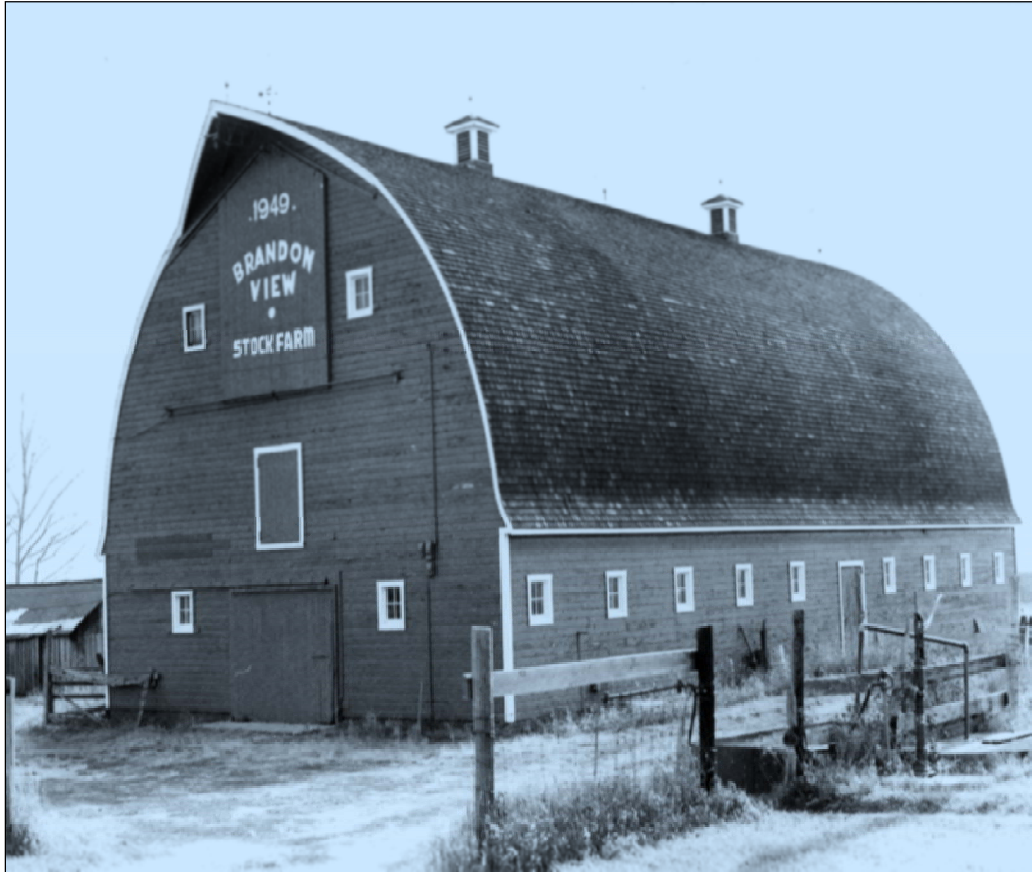
Figure 60
Hamilton Barn, NW 34-10-19W, 1949. The roof of this barn was constructed with laminated trusses that were built in Souris.

Farmers who built barns after the First World War usually relied on the same internal organization and construction procedures that were developed in earlier structures. Because the new barns were generally built exclusively for dairy cattle the longitudinal stable plan became predominant. New mechanical devices like the extended hay sling changed the profile of the barns, while new roof shapes were developed with later technological advances. However, it was the gambrel roof, the longitudinal stable alley, the hay sling and the loft framework developed for earlier barns that provided the basis for many later barn designs (Figure 60).
